# **Pedestrian Crossing - A507 Baldock Road, Cottered.**

## **1 EXECUTIVE SUMMARY.**

This report results from a commission under the Highways Locality Budget (HLB) of County Councillor Jeff Jones (Division 20 – Buntingford) where we have been asked to look at the possible installation of pedestrian crossing facilities on the A507 Baldock Road, Cottered, in the region of the access to the village hall.

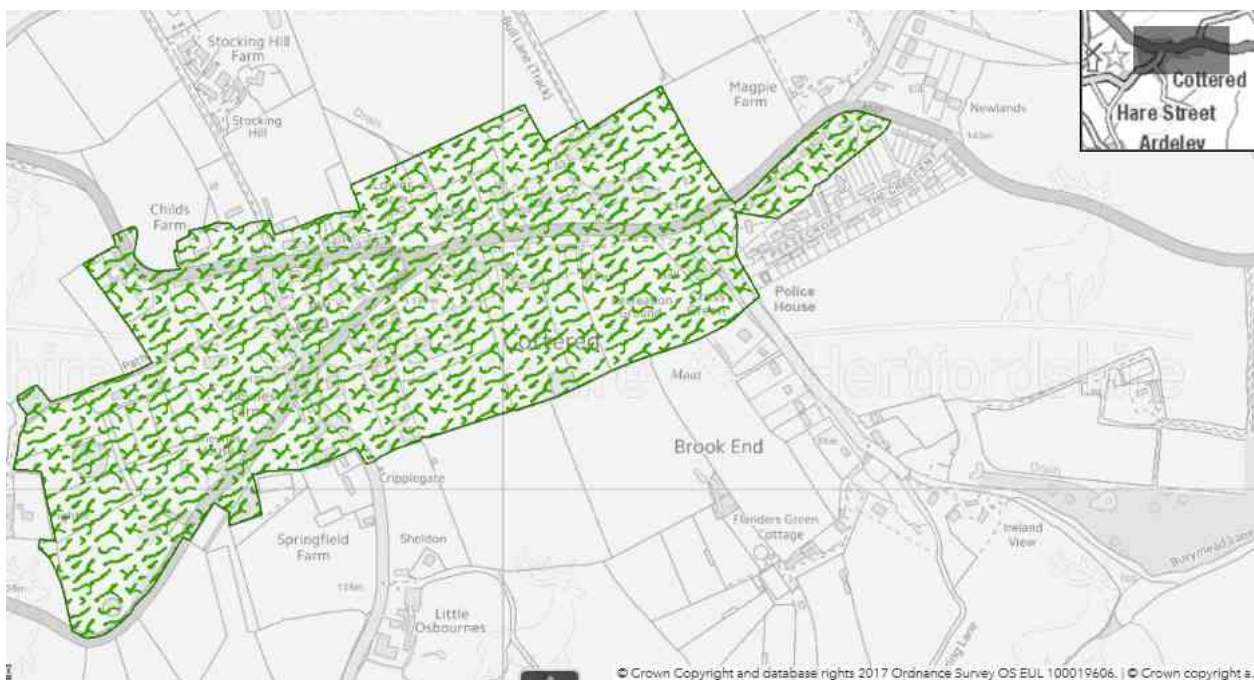
Figure 2: Conservation Area

The village of Cottered is a conservation area as shown by the green hatched area in Figure 2. This places constraints over what works can be undertaken in such an area and, should street lighting be a requirement of a scheme, mean that the choice of lamp columns is more expensive than the use of standard ones.

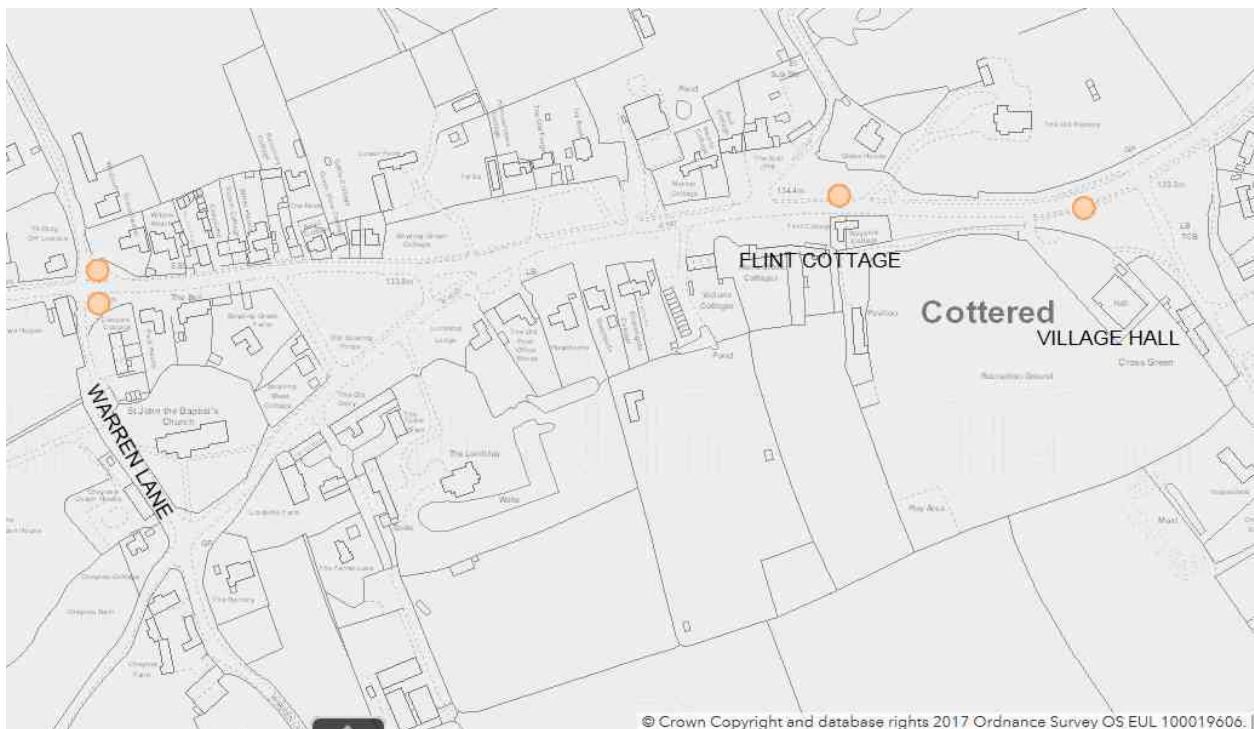
Figure 4 – Bus stop locations

There are four bus stops on the A507 in Cottered two for eastbound buses and two for west bound buses. At Warren Lane the bus stops are on opposite sides of the road to each other. The other two

stops are opposite Flint Cottage for eastbound buses and at the village hall access for westbound buses. These locations are shown as orange dots in figure 4.

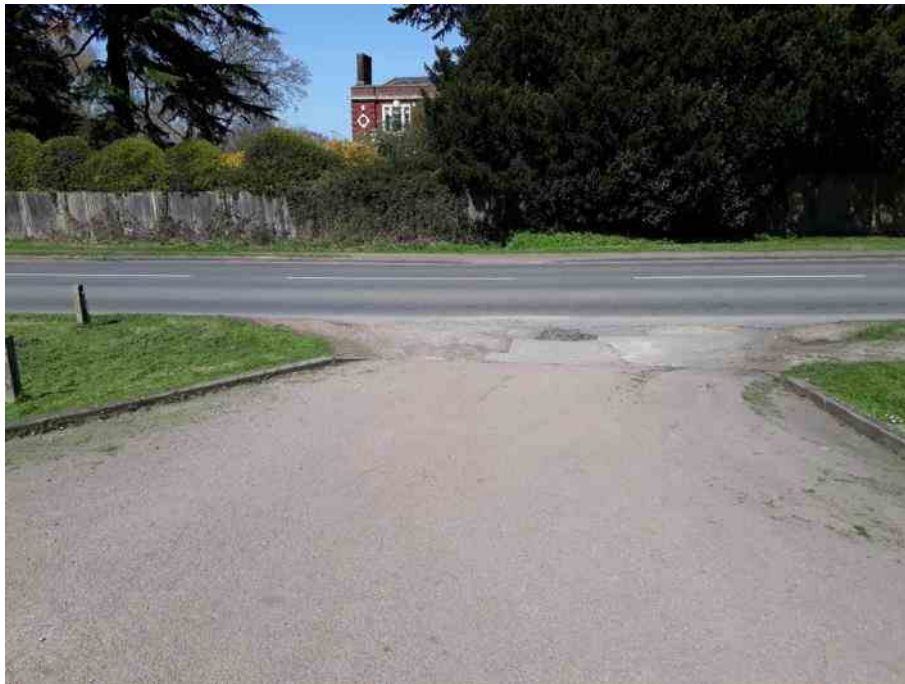
Pic 1 – View from village hall access to existing dropped kerbs.

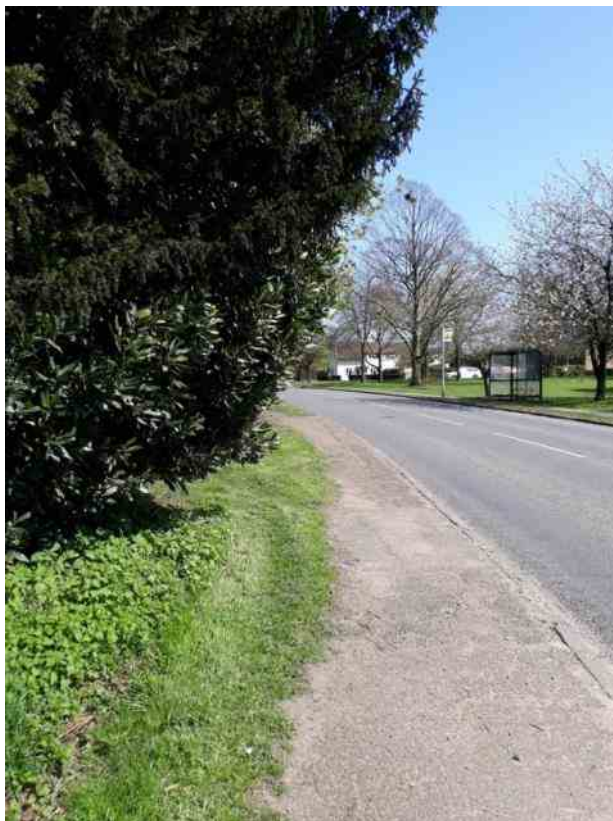
Pic 2 – Pedestrian visibility to the north east approx 1.5m from kerb at existing location.

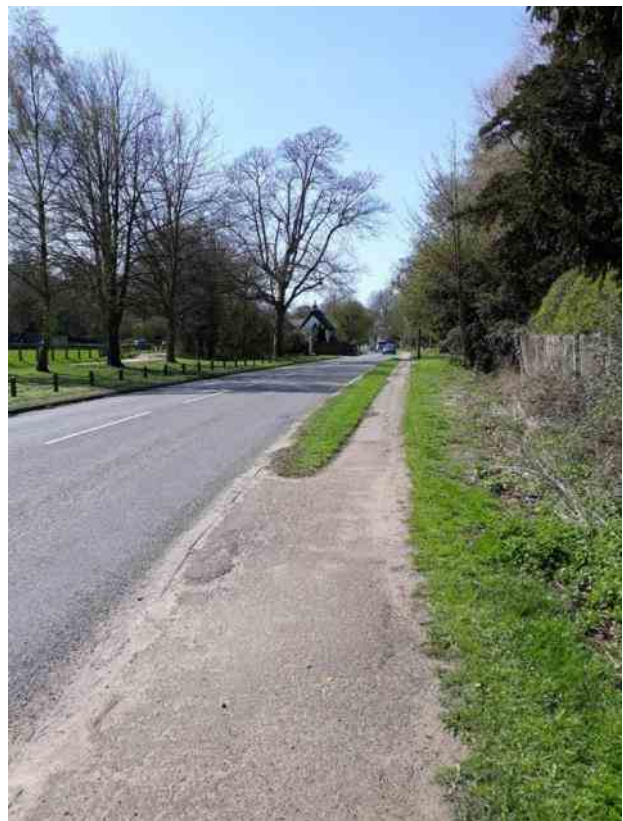
Pic 3 – Pedestrian visibility to the west approx 1.5m from kerb at existing location.

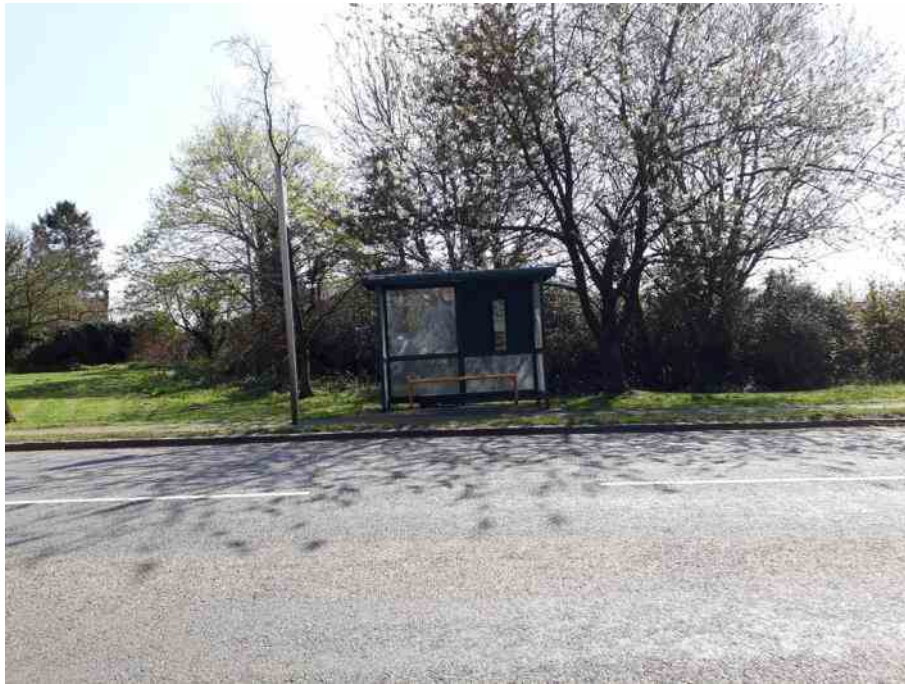
Pic 4 – View across to existing bus stop at alternative crossing location.

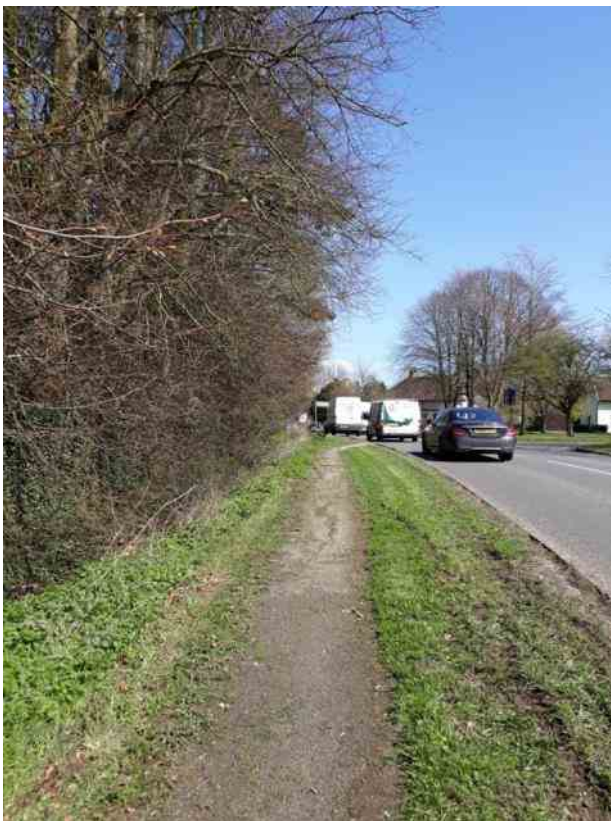
Pic 5 – Pedestrian visibility to the north east approx 1.5m from kerb at alternative location.

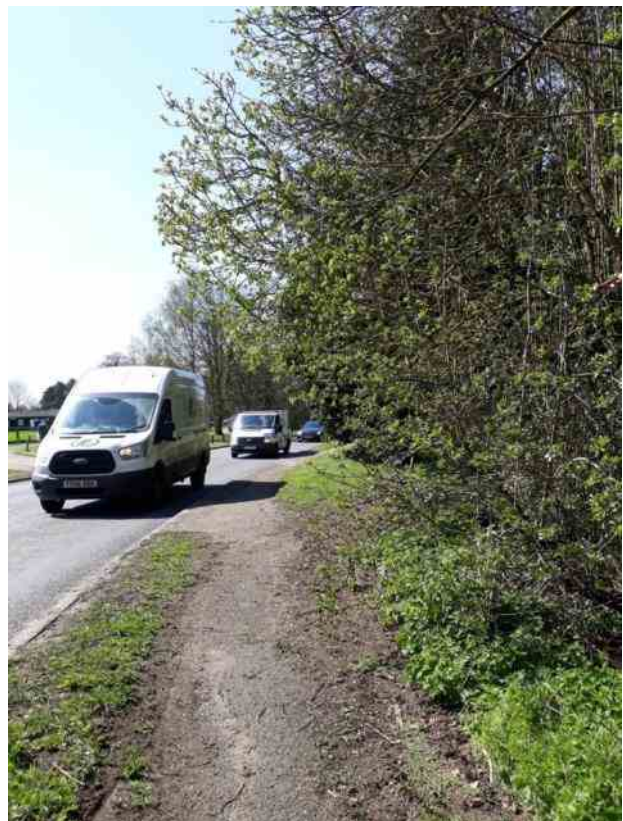
Pic 6 – Pedestrian visibility to the west approx 1.5m from kerb at alternative location.

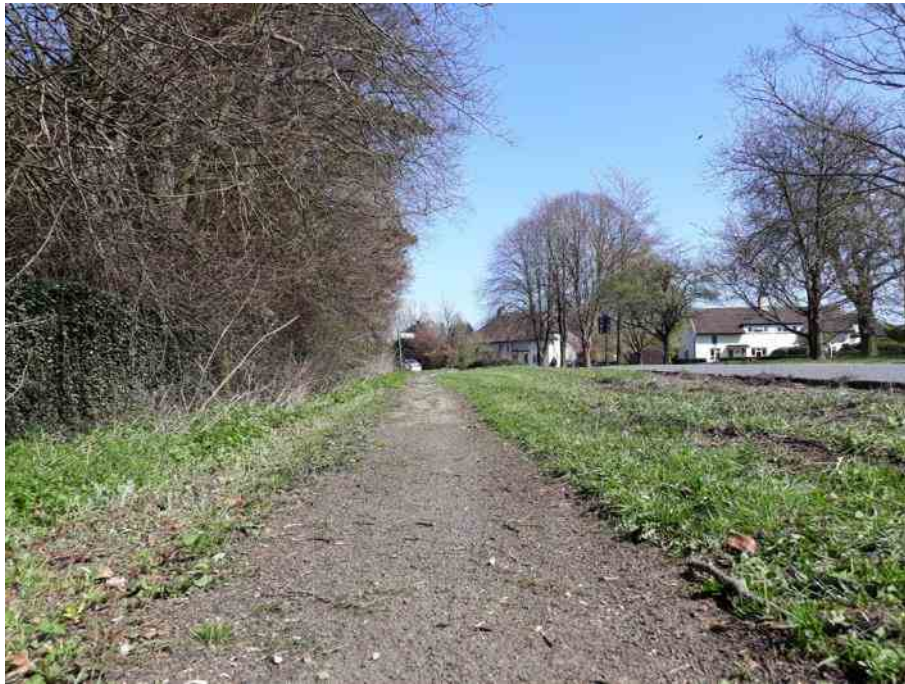
Pic 7 – View to show level differences between footway and carriageway at alternative crossing location

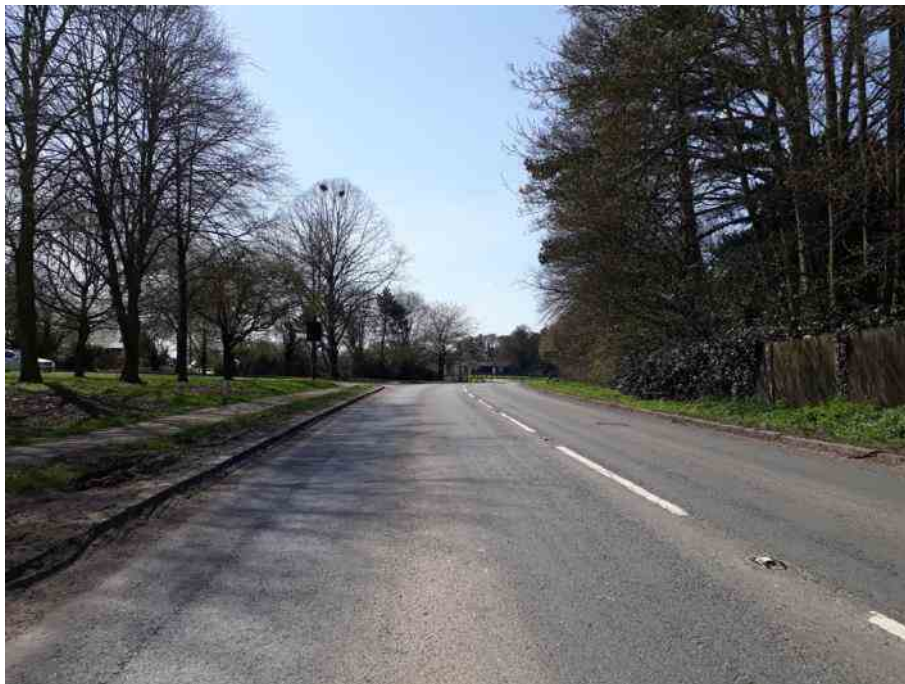
Pic 8 – View looking south west towards alternative location at drivers eye level approx 60m away. Shows change in road level.

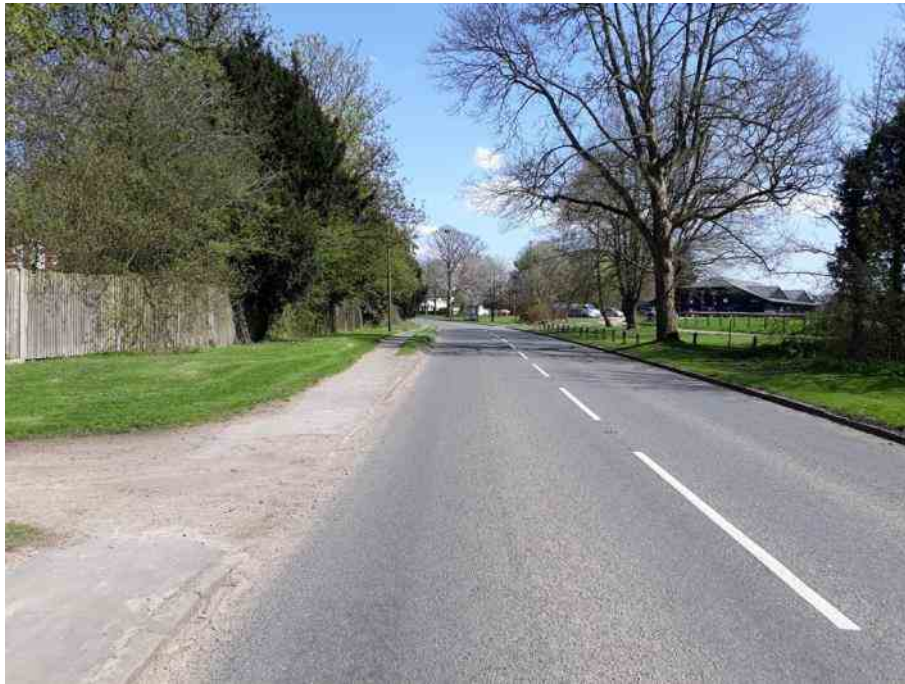
Pic 9 – View looking east towards both existing and alternative locations from approx 50m away on drivers approach.

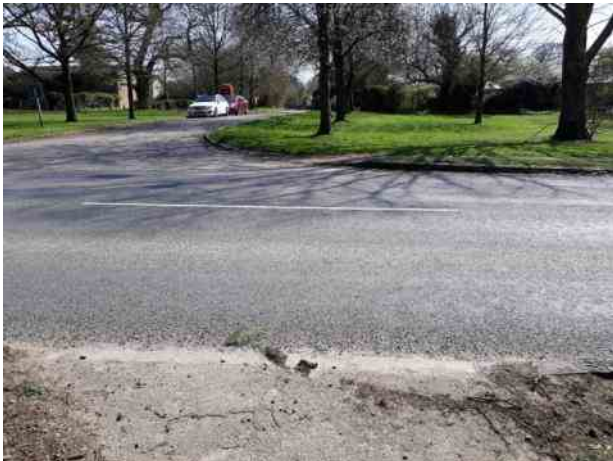
Pic 10 – Looking across to Brook End at other existing crossing point.

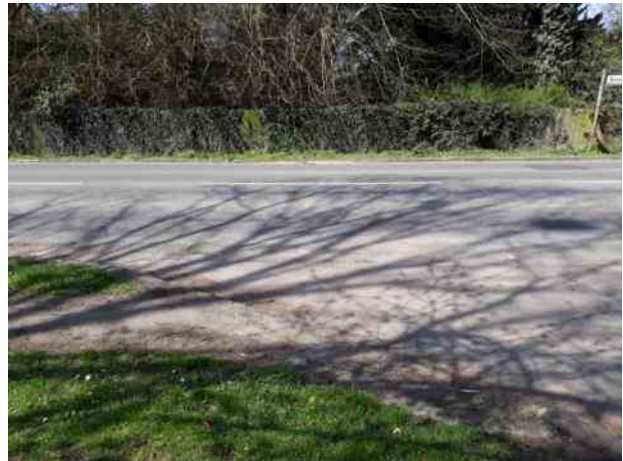
Pic 11 – Looking across from Brook End at other existing crossing point.

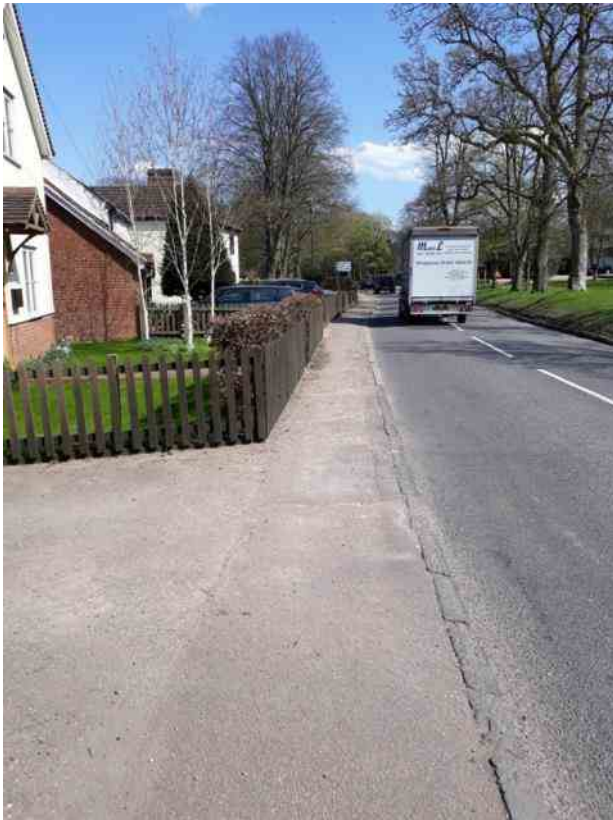
Pic 11 – Example of north side footway condition in the west of the village.

Heading west through the village, those footways that exist are probably not the most attractive to pedestrians being of uneven surfaces with dirt and detritus over the surface and built up at the rear.

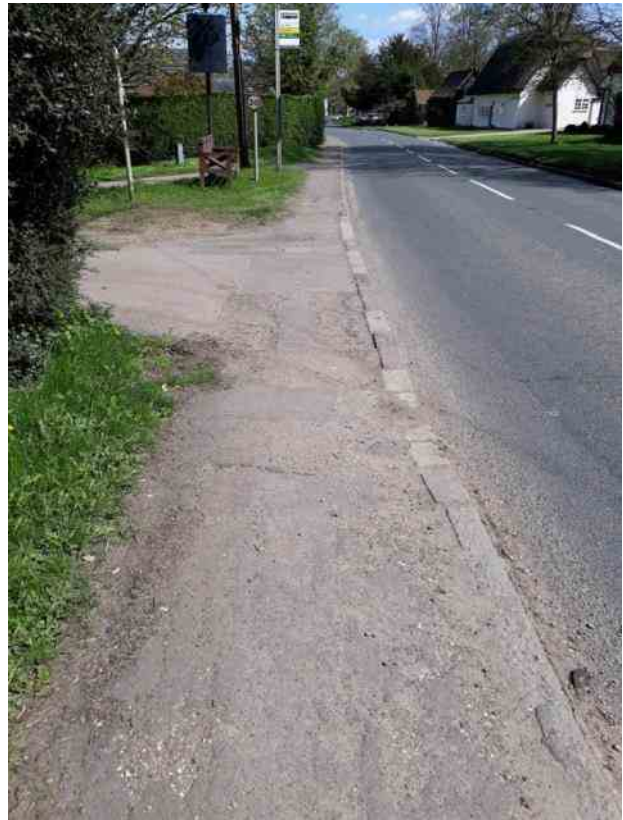
Pic 12 – Example of north side footway condition in the west of the village. Near Coopers Coppices.
